AUSTRALIAN PROPERTY &
— BUILDING INSPECTIONS —

Building Inspection Report

Building & Pest Inspection

Brief description of the building and other structures on the property:		
Type:	Domestic	Freestanding House
Bedrooms:	Four	
Bathrooms:	Three	
Car Park:	None	
Height:	Single Storey	
Building:	Brick Veneer	
Piers:	Concrete	
Floor:	Timber	
Roof:	Tile	
Age:	1970s	
Image of property:

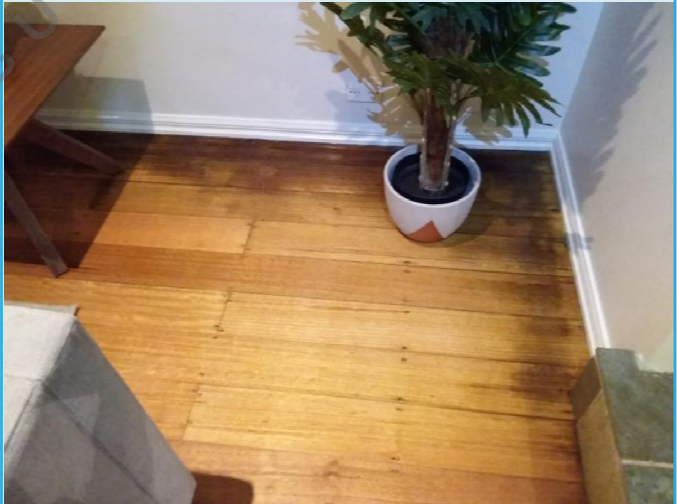
Hallways and General Living Spaces	
General Advice on Item	Floor
Comments	
<p>Floor discoloured near the kitchen, probably from previous plant watering, was dry at the time of inspection.</p>

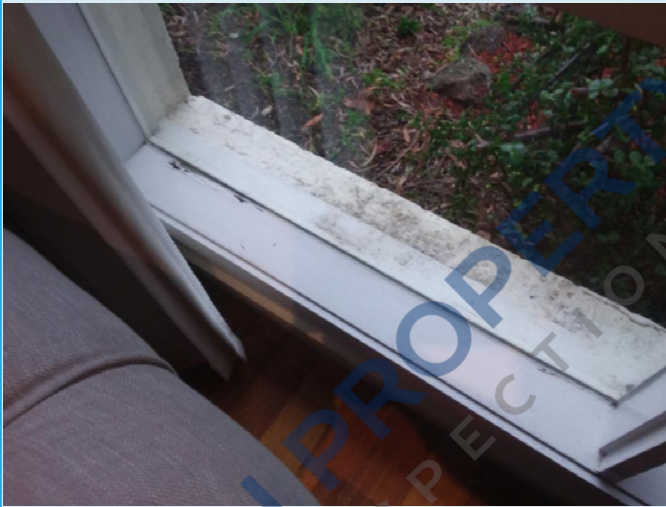
Hallways and General Living Spaces	
Repair Recommended	Windows
Comments	
Moderate fungal decay to window frame in the front lounge-room area.

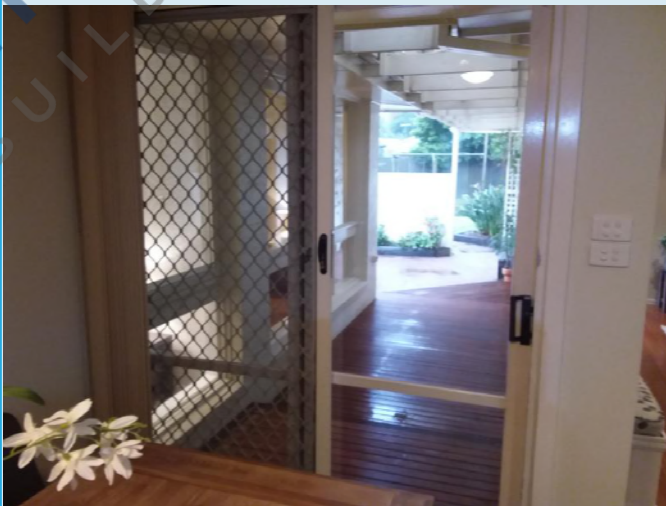
Hallways and General Living Spaces	
Repair Recommended	Doors
Comments	
Door was unable to be opened.

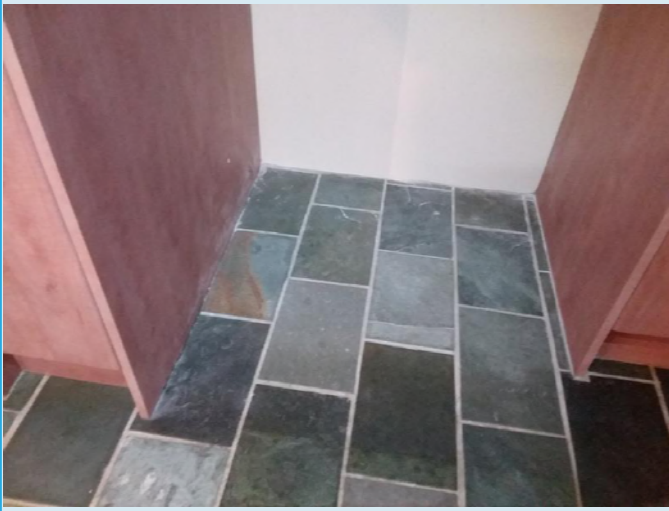
Kitchen	
Repair Recommended	Sealants
Comments	
Sealant is recommended to be installed around wall, kick-boards and tiles to avoid possible water intrusion.

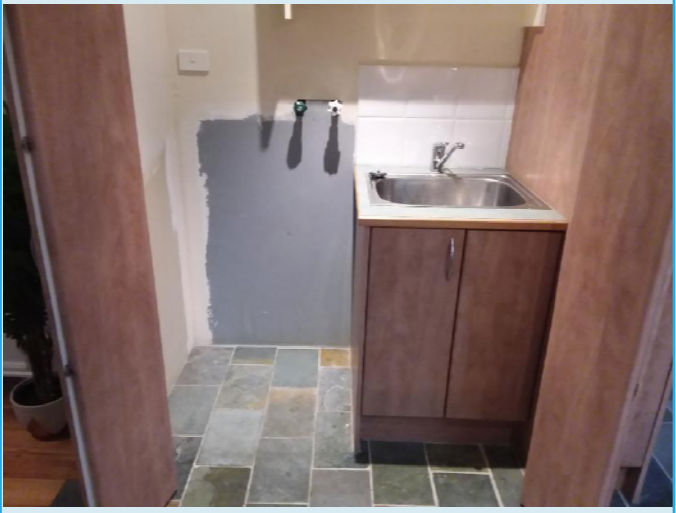
Laundry	
General Advice on Item	
Comments	
<p>Laundry is unfinished. Recommend flanges around taps to cover gaps in the wall, sealants at floor tiles, and paint to seal the walls. Otherwise visually fine at the time of inspection.</p>

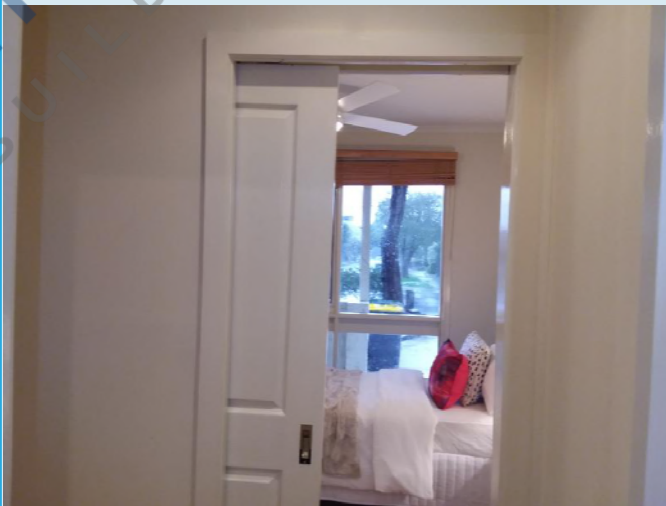
Bedrooms	
Repair Recommended	Doors
Comments	
Bedroom 2 door did not slide, and should be rectified.

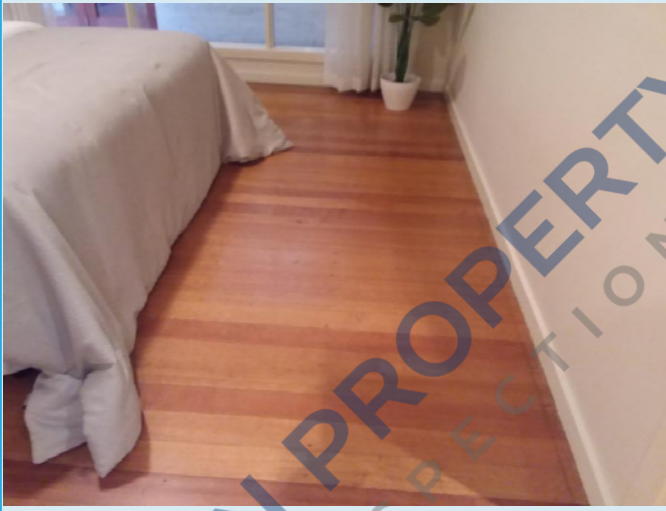
Bedrooms	
General Advice on Item	Floor
Comments	
Bedroom 4, Squeaky floorboards can be wedged from below.

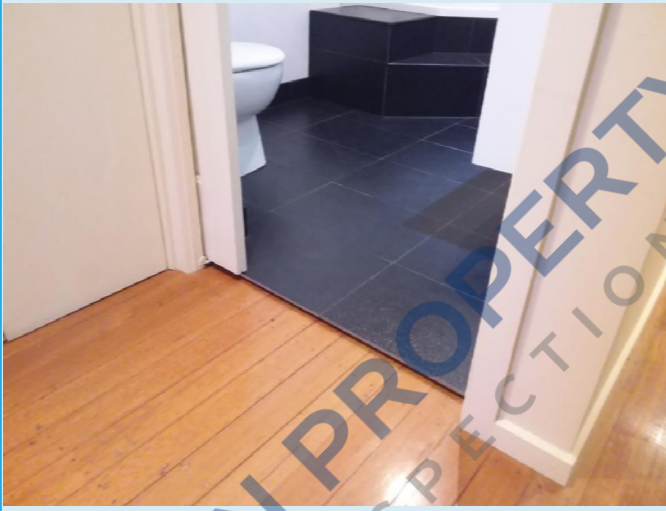
Bathrooms	
Repair Recommended	Floor
Comments	
Tiles edging is unfinished.

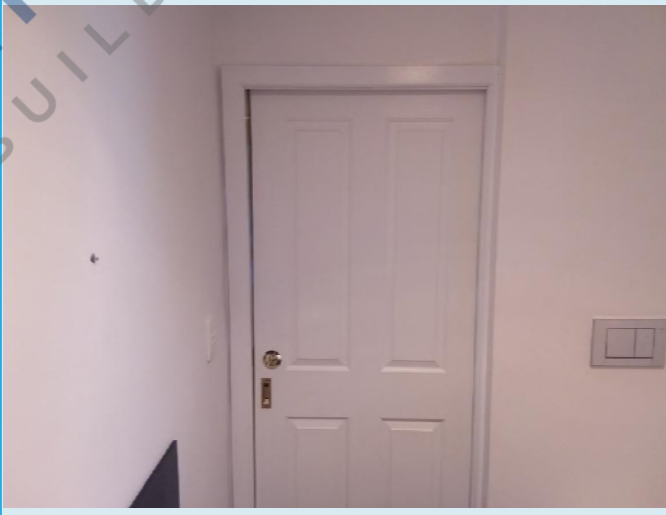
Bathrooms	
Repair Recommended	Doors
Comments	
Adjust door to close and lock properly.

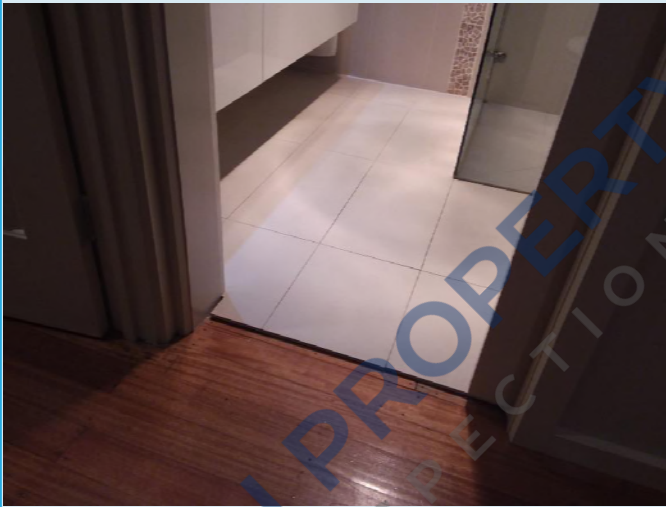
Ensuite	
Repair Recommended	Floor
Comments	
Tile edging is unfinished.

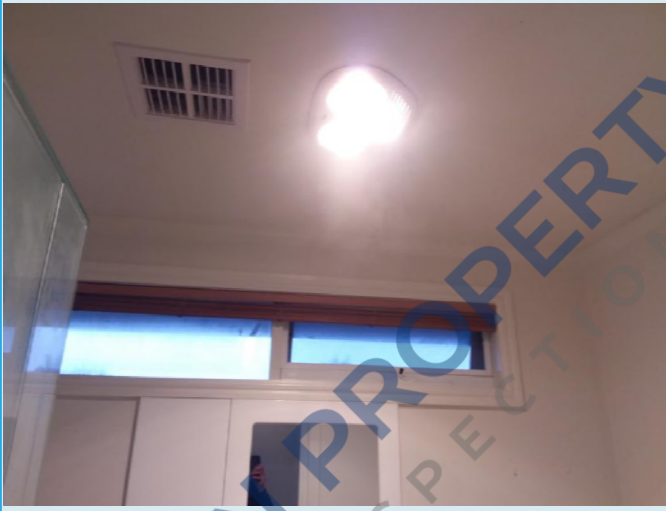
Ensuite	
Repair Recommended	Exhaust Fan
Comments	
Rear ensuite, exhaust fan was not functioning, and should be rectified to avoid damp buildup and mould.

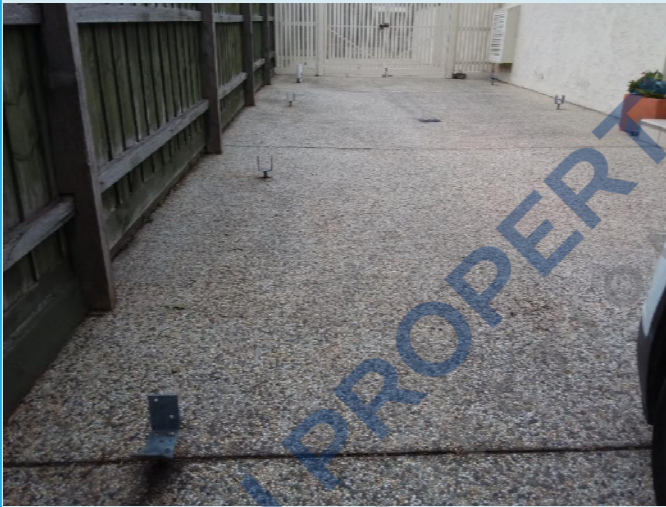
External	
General Advice on Item	Driveways and Paths
Comments	
There are metal stirrups at the driveway edges, presumably for carport posts, which could be hazardous.

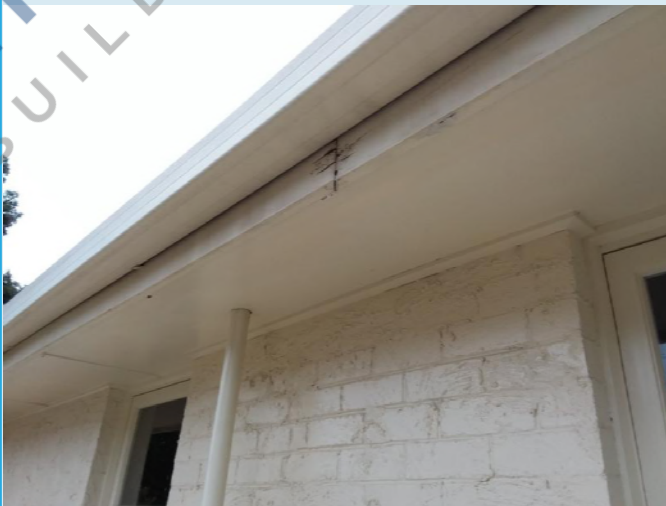
External	
Repair Recommended	Fascia
Comments	
Timber pest damage to fascia boards and rear pergola. See the comments below.

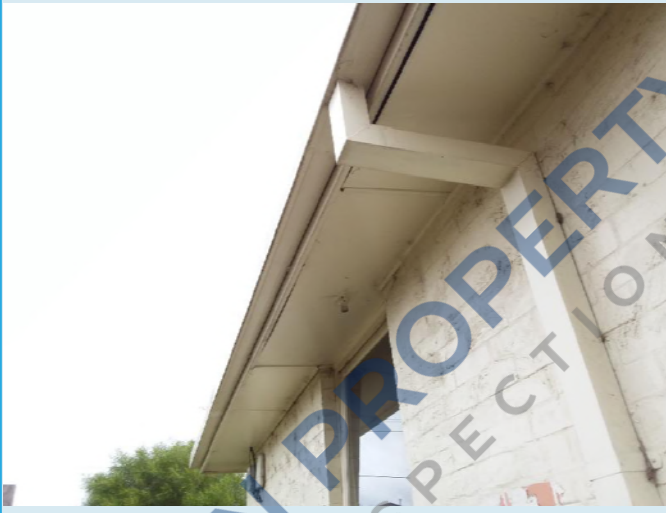
External	
Repair Recommended	Eaves
Comments	
Eaves lining boards are loose on the south side of the house and should be refixed.

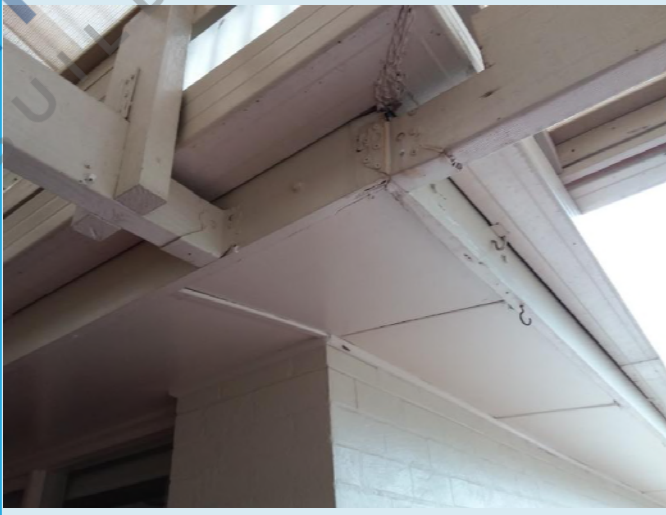
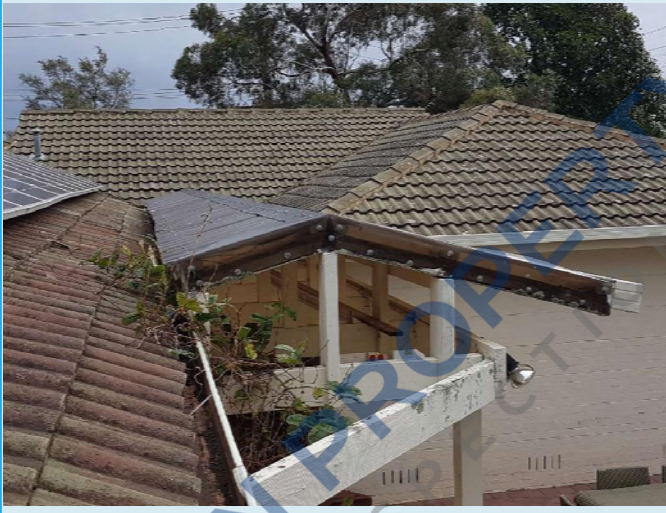
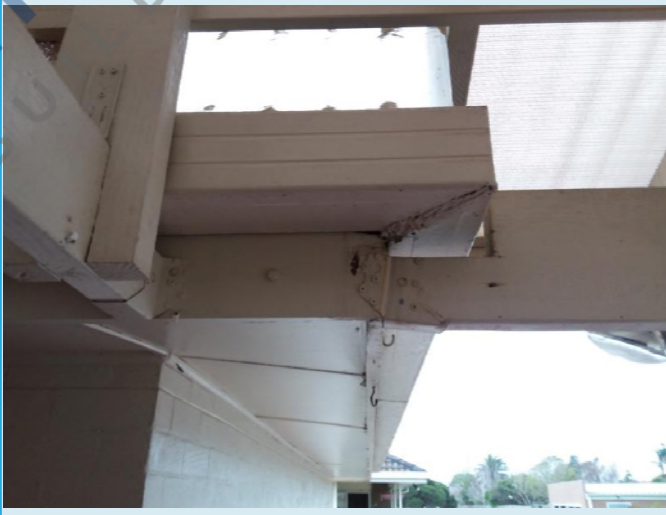
External	
Major Structural Defect	Roof
Comments	
Heavy decay to the fascia boards corner where the awning beam structure is screw fixed. The eaves have sagged at the corner due to weight of the structure, which appears to cause water overflow from the sagging gutter, and should be rectified to avoid ongoing decay. The awning beam is checked out around the gutter and undersized where connected. The awning could collapse, and should be rebuilt for safety as soon as possible. Rectify the sagging eaves. Replace the gutter to enable water to drain properly to down-pipes.

External	
Major Structural Defect	Roof
Comments	
As above.

External	
Major Structural Defect	Roof
Comments	
As above, closer photo.

Roofed awning area should be repaired or replaced, as detailed in the comments above.

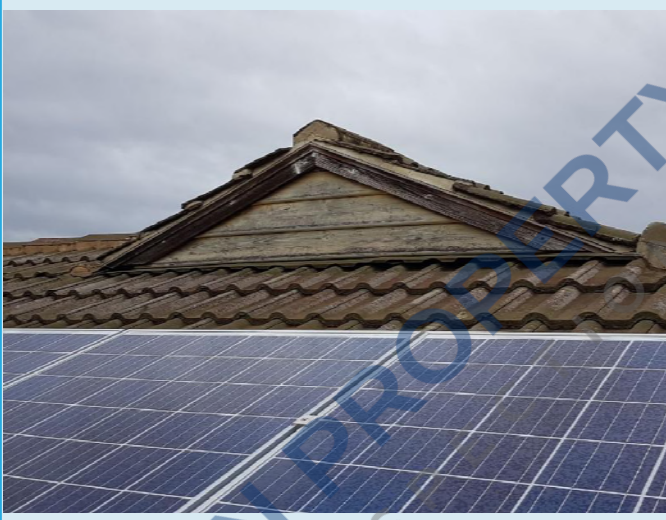
External	
Repair Recommended	Roof
Comments	
Gaps in the roof edging at gable end should be rectified to prevent possible roof leaks.

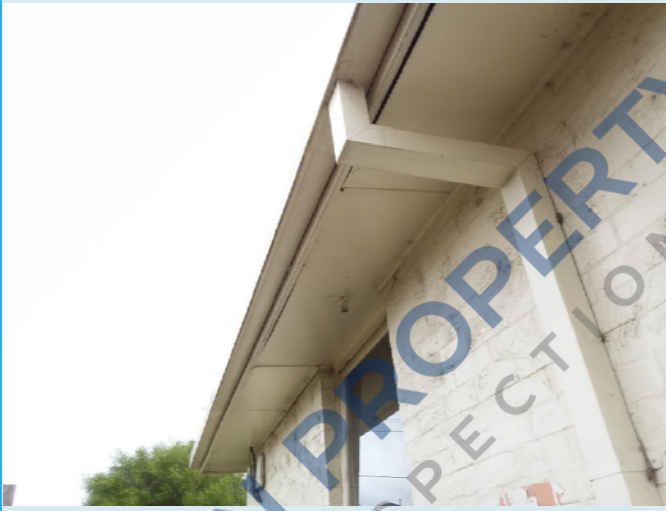
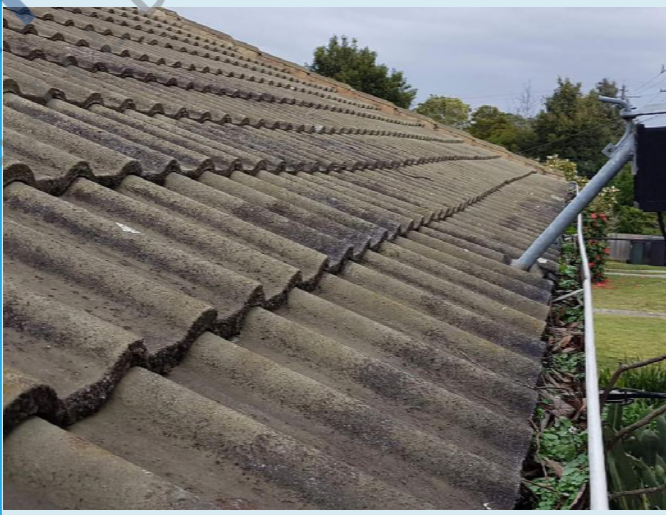
External	
Repair Recommended	Down Pipes
Comments	
Down-pipes and gutters show rust holes in places and moderate surface rust, painted over. Recommend replacing gutters and down-pipes.

External	
Repair Recommended	Gutters
Comments	
As above.

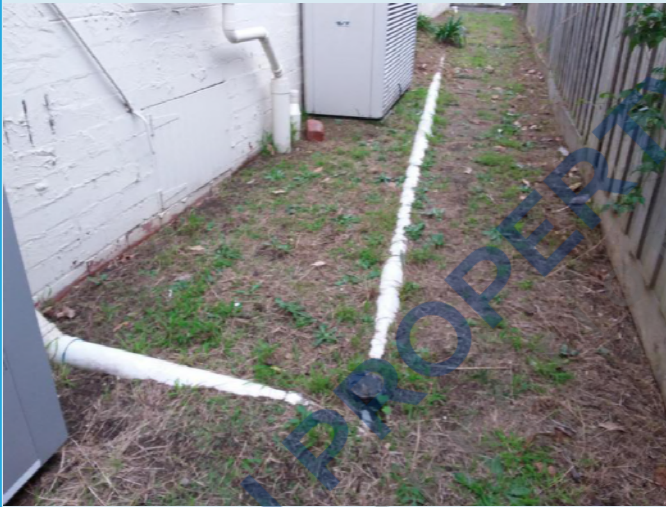
External	
Repair Recommended	Drainage
Comments	
Drainage pipes are exposed and prone to damage. Recommend a plumber to assess all plumbing and advise on costs to rectify where needed.

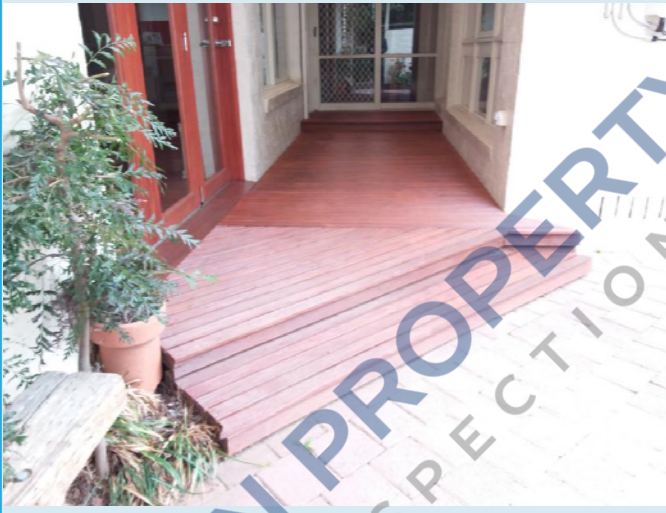
External	
Unable to Inspect Due to Access	Deck
Comments	
<p>Unable to inspect the rear deck subfloor area. Where visible, appeared fine at the time of inspection, although slightly springy.</p>

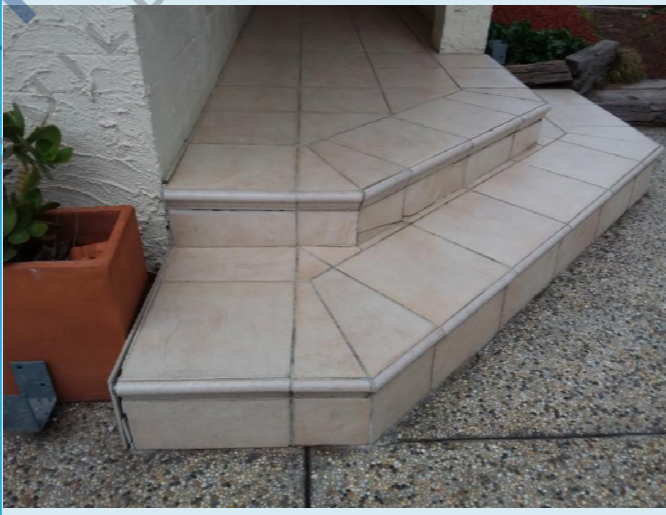
External	
Repair Recommended	Porch
Comments	
<p>Some porch tiles are cracked. Replace at your discretion.</p>

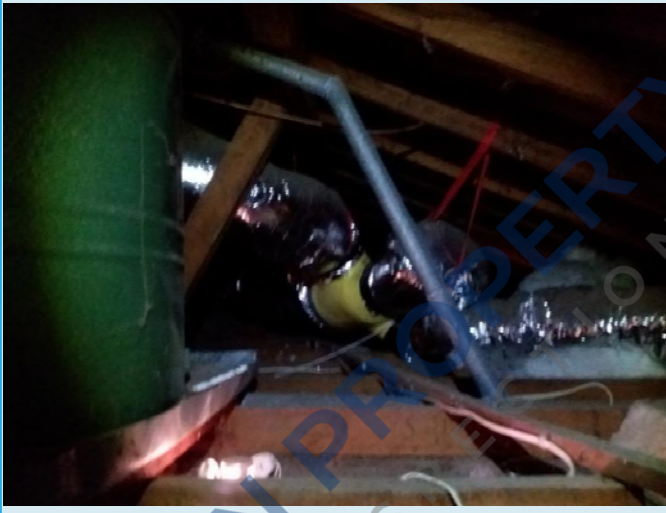
External	
Unable to Inspect Due to Access	Roof Space
Comments	
Unable to inspect the majority of the roof space due to obstructing ducts.

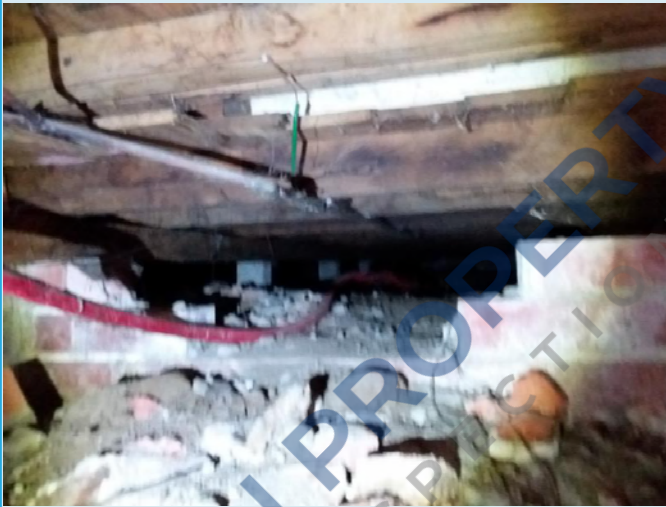
External	
Unable to Inspect Due to Access	Stumps
Comments	
Sub-floor was not accessible for inspection under the lower floor section of the house, due to low clearance.

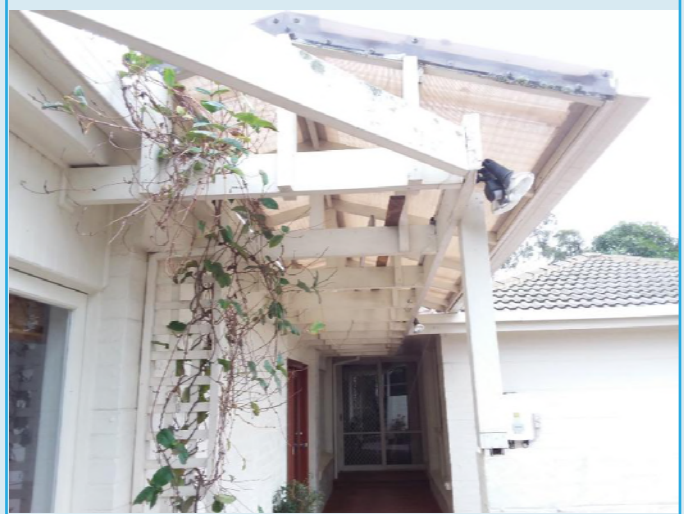
Heavy fungal decay to several external areas, as detailed in the building section of the report.

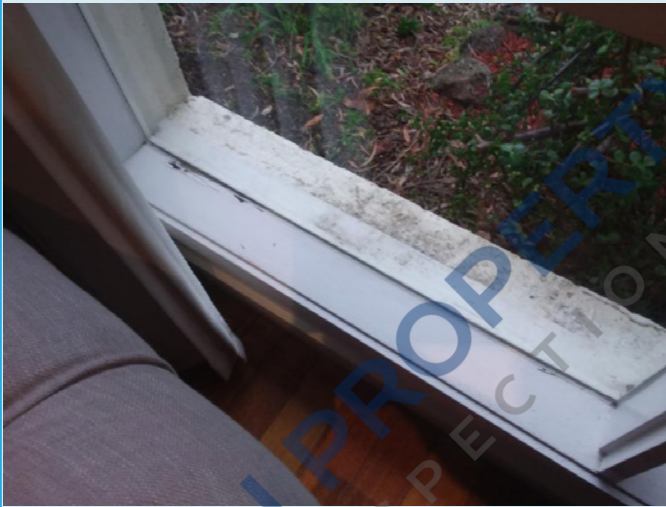
Timber Pest - Findings and Recommendations	
Activity or Damage Advice on Item	Windows
Comments	
Moderate fungal decay to the window frame, should be repaired.

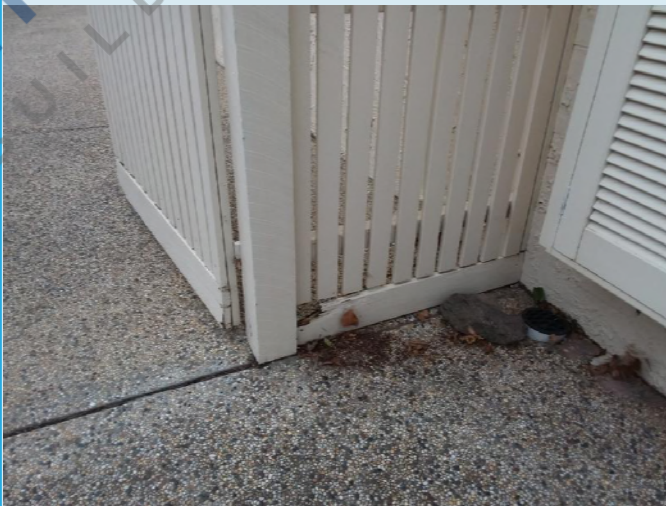
Timber Pest - Findings and Recommendations	
Activity or Damage Advice on Item	Fence line
Comments	
Moderate fungal decay to sections of fencing.

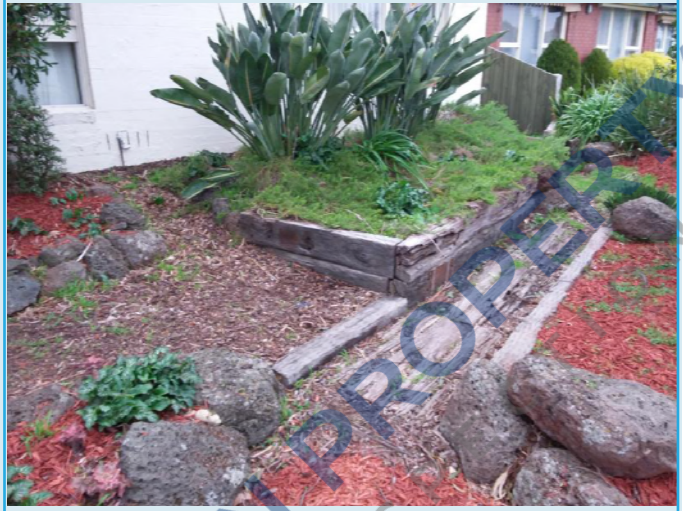
Retaining walls, garden edging and timber paths are an attraction to termites and should be replaced with durable materials.
