## Building Inspection Report

Type of Report: Dilapidation Inspection

Brief description of the building and other structures on the property:		
Type:	Domestic	Townhouse
Bedrooms:	Three	
Bathrooms:	Two	
Car Park:	Double	
Height:	Single Storey	
Building:	Brick Veneer	
Piers:	Brick	
Floor:	Slab	
Roof:	Tile	
Age:	2000s

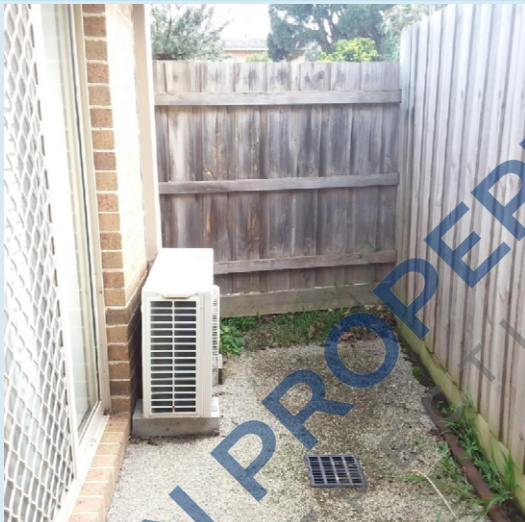
External	
Condition Visually Fine	-
Comments	
<p>Courtyard from bedroom 2 appears to be visually fine at time of inspection however ground level within this courtyard is approximately 200mm below neighbouring property.</p>

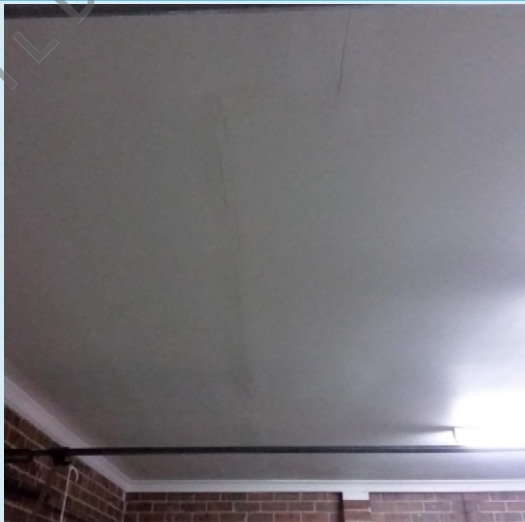
External	
General Advice on Item	-
Comments	
<p>Courtyard from bedroom 3, all structural elements of dwelling appear to be visually fine at time of inspection however significant damage is evident to fencing and this requires replacement or reinforcement.</p>

External	
General Advice on Item	Eaves
Comments	
Eaves within courtyard from bedroom 3 has some minor damage on south corner where it appears the eaves has dropped slightly and cracking is evident.

External	
General Advice on Item	Garage/Car Port
Comments	
Cracking and movement of ceiling joints in garage is evident.

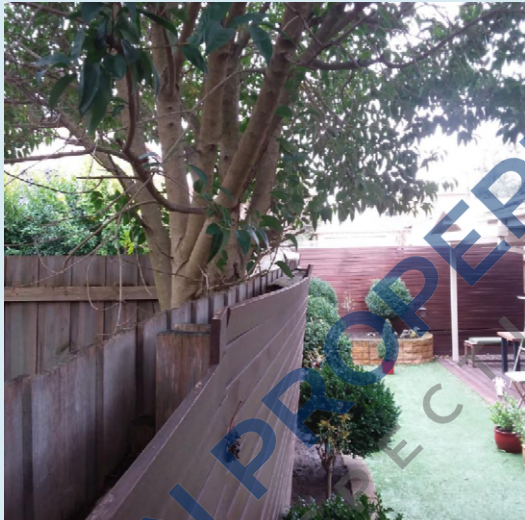
External	
General Advice on Item	-
Comments	
Rear boundary fencing has been installed poorly and is not plumb and straight.

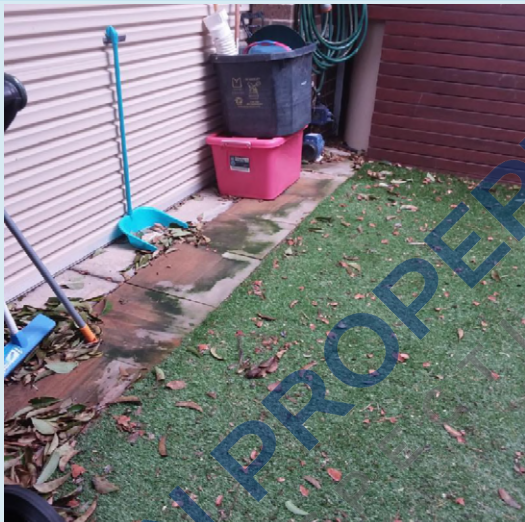
External	
General Advice on Item	-
Comments	
A horizontal decking board used as screening against west boundary fence near pergola has become dislodged and requires securing in position.

External	
General Advice on Item	Driveways and Paths
Comments	
<p>Pavers around perimeter of dwelling in backyard have settled inconsistently and as a result water may pool around dwelling perimeter.</p>

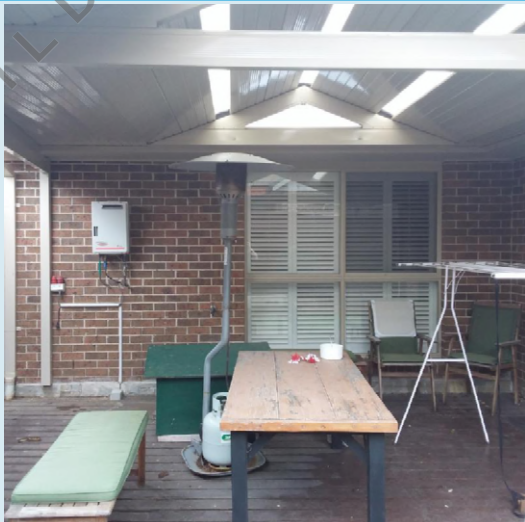
External	
Condition Visually Fine	Pergola
Comments	
<p>Pergola area appears to be visually fine at time of inspection.</p>

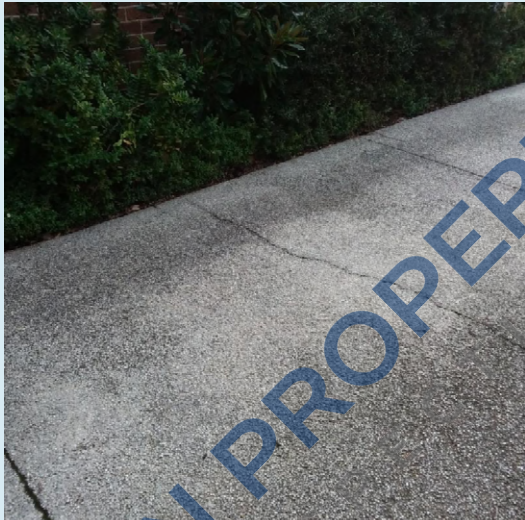
External	
General Advice on Item	Driveways and Paths
Comments	
Minor cracking of up to 3mm wide in driveway on East side of property.

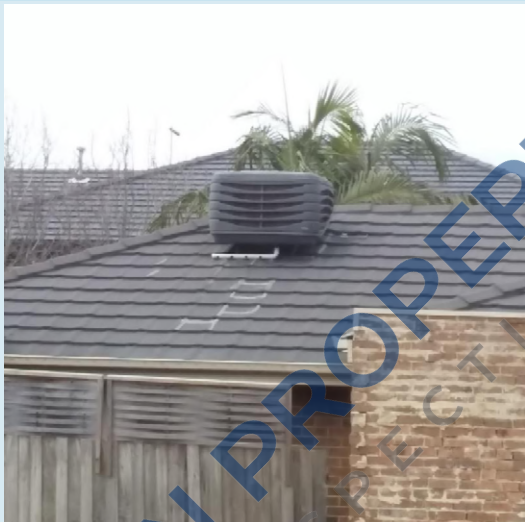
External	
General Advice on Item	Walls
Comments	
External wall on South side of ensuite and walk in robe has been completed to a poor finish, it appears this was originally build against a structure on adjoining property and the brick work has not been cleaned of excess mortar and there are a number of perpend that are not completely full of mortar.

External	
General Advice on Item	Roof
Comments	
6 roof tiles near evaporative cooling unit on roof appear to have been repaired with silicone or similar where these have previously been cracked.

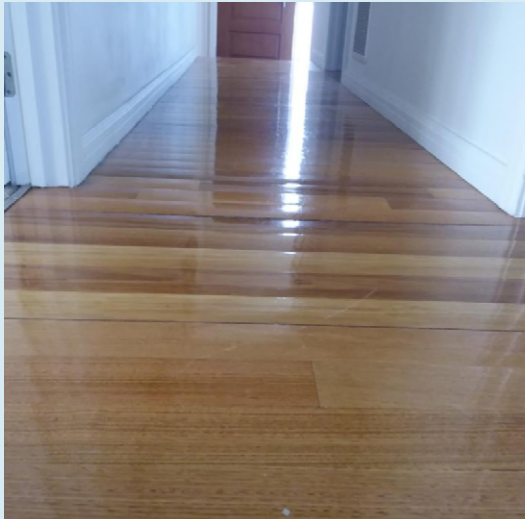
Internal	
General Advice on Item	Entry/Hallway
Comments	
Hallway flooring.

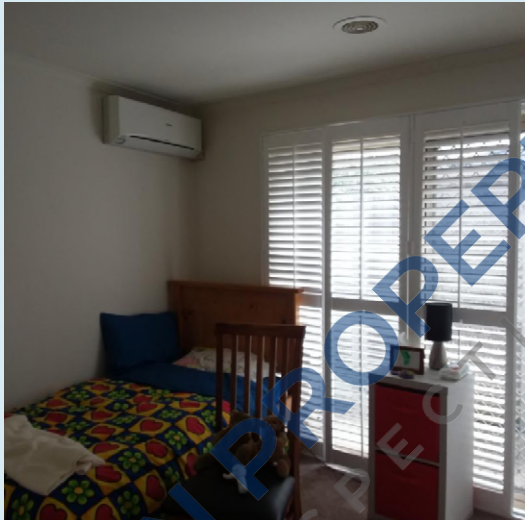
Internal	
Condition Visually Fine	Bedroom 2
Comments	
Bedroom 2 appears to be visually fine at time of inspection.

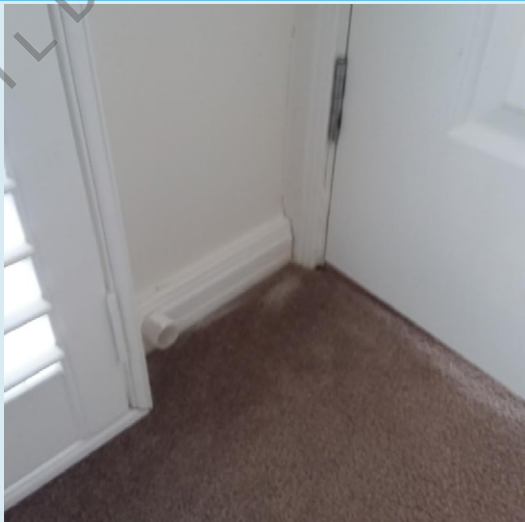
Internal	
General Advice on Item	Bedroom 3
Comments	
Minor cracking between skirting board and door architrave is evident.

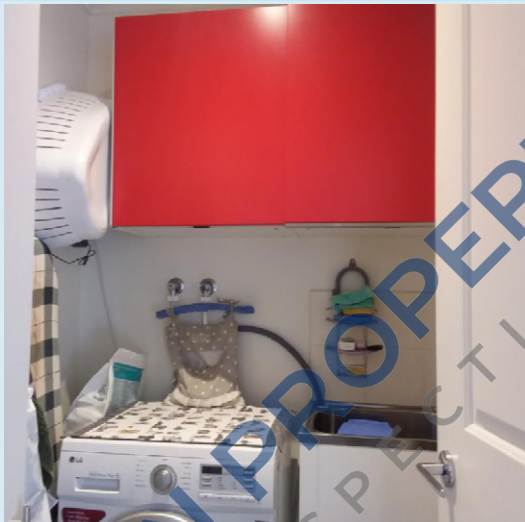
Internal	
Condition Visually Fine	Laundry
Comments	
Laundry appears visually fine at time of inspection.

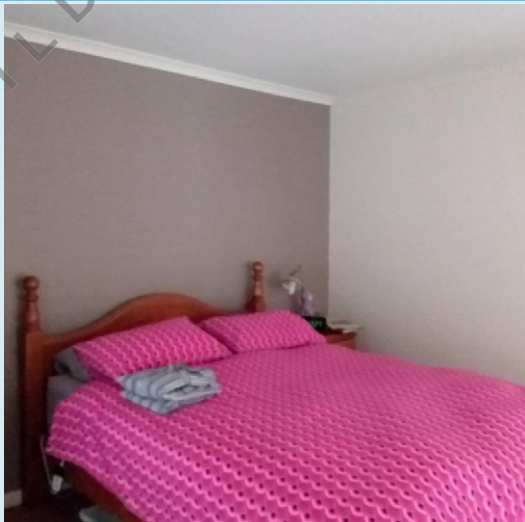
Internal	
Condition Visually Fine	Bedroom 1
Comments	
Bedroom 1 appears to be visually fine at time of inspection.

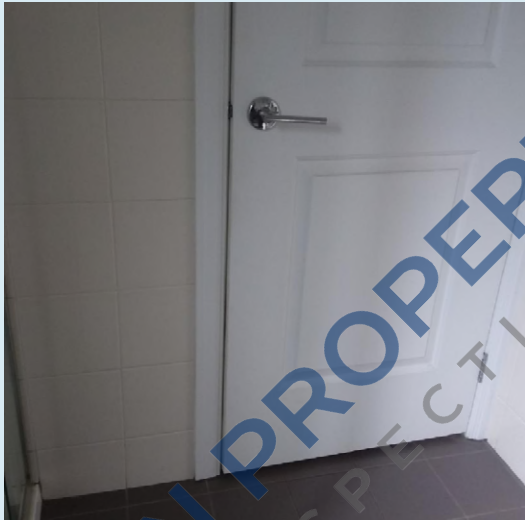
Internal	
General Advice on Item	Ensuite
Comments	
<p>Ensuite door is striking jamb when closing and some minor surface damage is evident to door.</p>

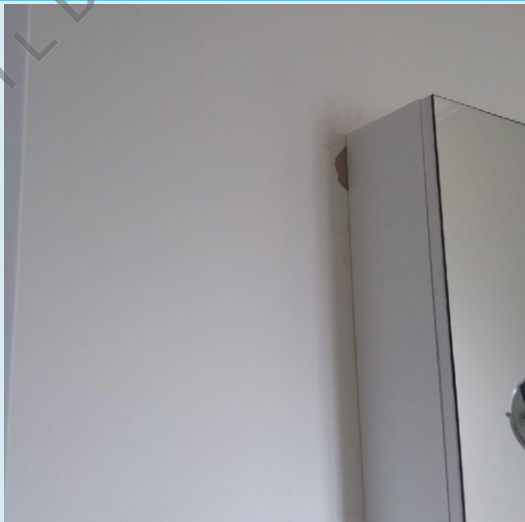
Internal	
General Advice on Item	Ensuite
Comments	
<p>Minor surface damage to wall on left side of shaving cabinet and grout above top edge of wall tiles has not been completed below cabinet.</p>

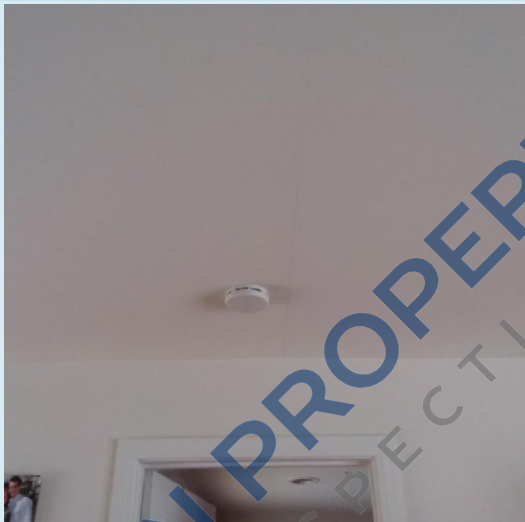
Internal	
General Advice on Item	Family Room
Comments	
Some hairline cracking in ceiling joints of living area including in line with bedroom 1 and laundry doors.

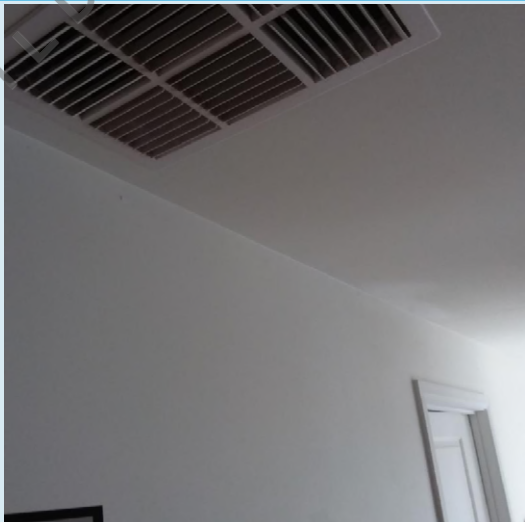
Internal	
General Advice on Item	Family Room
Comments	
Some loose fixings in plaster walls and ceiling are evident in family room wall adjoining laundry.
